### HeatX Increases Heat Exchanger Performance While Inhibiting Corrosion and Biofouling

This case study describes Oceanit's program work with Hawaiian Electric Company's (HECO) Kahe power plant on the west coast of Oahu (Figure 1). The Kahe plant uses seawater to cool operational fluids, leading to biofouling in operational heat exchangers.

# CASE STUDY: HeatX & Hawaiian Electric Company (HECO)

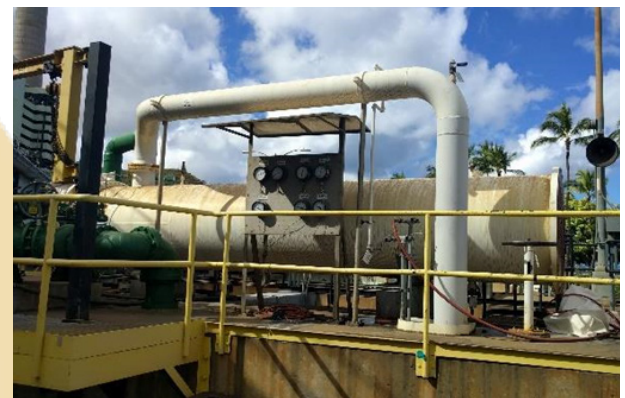
In Oceanit's application of HeatX, the subject heat exchangers at HECO had no coating or treatment other than a thick layer of epoxy to protect the stationary tube sheet from sand erosion. The epoxy coating, however, does not provide any fouling resistance.

**Figure 2:** Shell and Tube Heat Exchanger at Kahe (HECO)

The initial subject heat exchanger at HECO was a horizontal, 4-pass, TEMA type BEM (fixed tube sheet) containing approximately 1000 x .75" OD x 20' long SA179 carbon steel tubes (Figure 2). It is one of a train of identical chillers fitted to the turbines at the power plant. In December 2016, the corroded exchangers were isolated, cleaned and one was treated on-site with HeatX surface treatment. For a period of six months after reintroduction into service, performance was closely monitored against identical, untreated chillers. As untreated heat exchangers' performance started to falter, the HeatX unit showed no signs of deterioration.

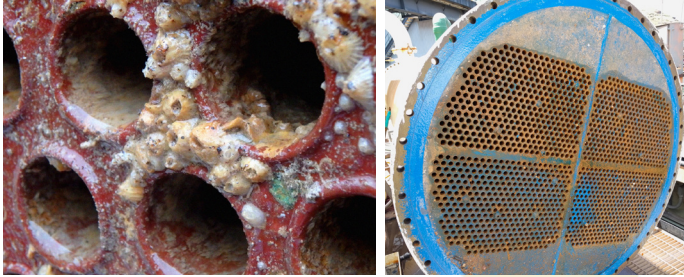
After six months, the units were again taken out of service for inspection (Figure 3). The HeatX-treated unit showed no signs of blockage or fouling buildup, unlike the non-treated units which had been cleaned at the same time in December 2016. The untreated units had significant fouling and debris which had begun to affect performance, as was typical. The HeatX unit, needing no maintenance, was promptly put back into service.

**Figure 3:** Untreated tubulars six months after a standard cleaning vs. HeatX-treated heat exchanger after six months in service: no maintenance was required.

During the initial six-month period, HECO monitored the seawater, auxiliary chiller water inlet & outlet temperature, and the overall power generation from the turbine associated with HeatX versus an untreated chiller. The six-month inspection showed a negligibly thin layer of biofilm and debris but no signs of blockage or barnacle build up.

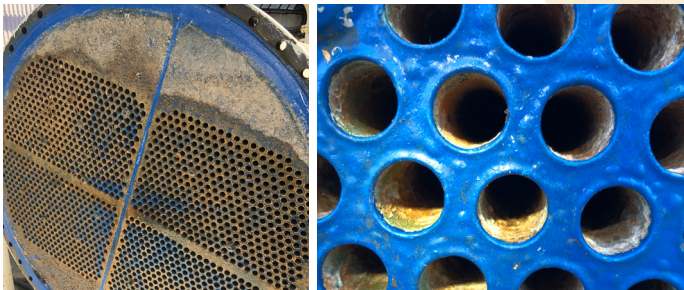
**Figure 4:** Left: HeatX-treated heat exchanger after 26 months in service. Right: Tube sheet after a simple pressure wash.

The heat exchanger was removed from service for a visual inspection in January, 2019. A pressure wash with water easily cleared all debris from the tube sheet and visual inspection showed that HeatX was still fully functional. The unit is now being returned to service, still without any need for further cleaning or maintenance. (Figure 4).
